DEPARTMENT OF TRANSPORTATION

Quality Assurance and Source Inspection

Contract #: 04-0120F4Cty: SF/ALA Rte: 80 PM: 13.2/13.9File #: 69.15**SOURCE INSPECTION REPORT****Resident Engineer:**Pursell, Gary**Address:** 333 Burma Road**City:** Oakland, CA 94607**Report No:** SIR-000687**Date Inspected:** 18-Jun-2009**Project Name:** SAS Superstructure**OSM Arrival Time:** 0**Prime Contractor:** American Bridge/Fluor Enterprises, a JV**OSM Departure Time:** 12**Contractor:** Zhenhua Port Machinery Company, Ltd (ZPMC), Changxing Island **Location:** Changxing Dao, Shanghai

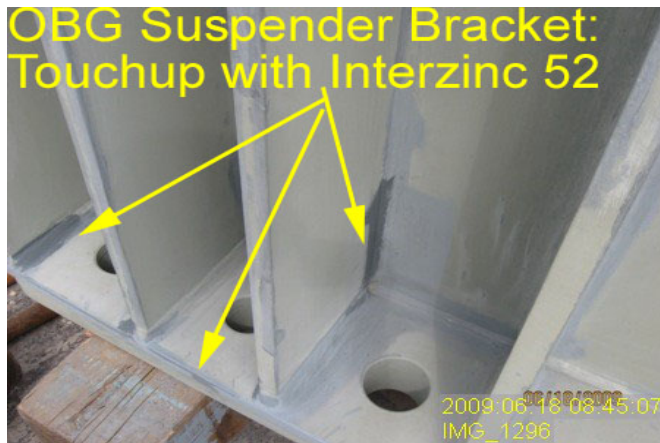
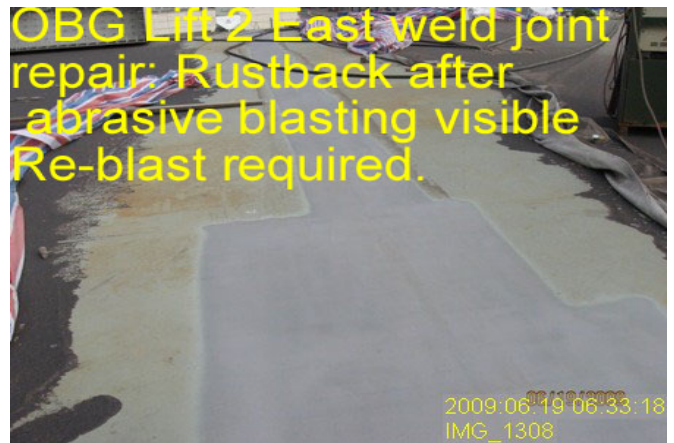
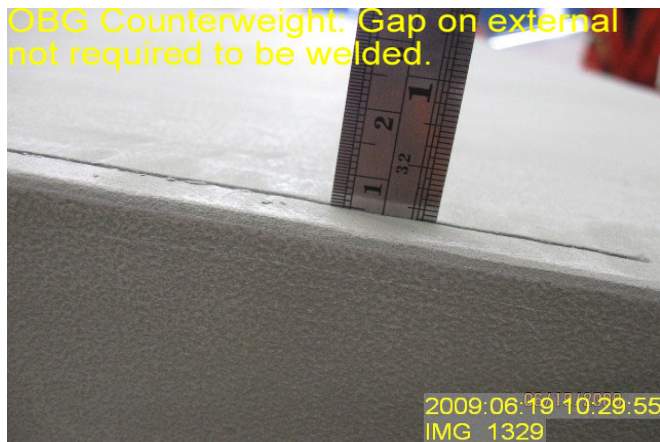
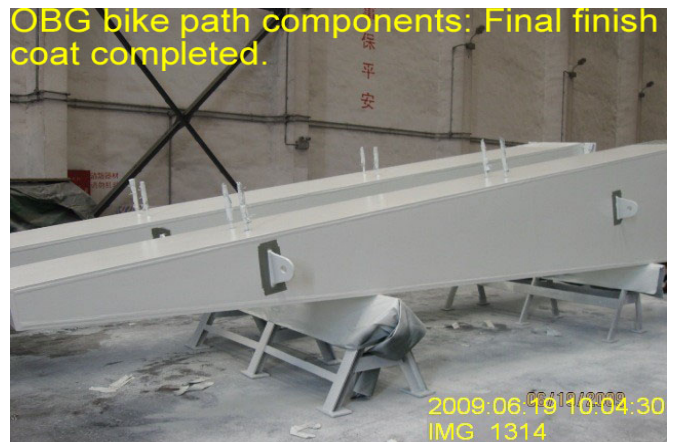
Fabrication on assembled components of the OBG's and Towers are not complete. Outstanding weld repairs have not been performed. Coating damage requiring re-blast is expected.
